Project Crested Ice. A joint Danish-American report on the crash near Thule Air Base on 21 January 1968 of a B-52 bomber carrying nuclear weapons

Project Crested Ice

A Joint Danish-American Report on the Crash Near
Thule Air Base on 21 January 1968 of a B-52
Bomber Carrying Nuclear Weapons

February, 1970

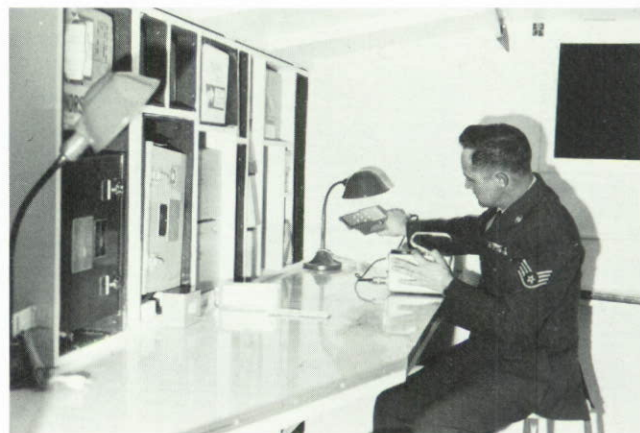
Inside the air-transportable radiac package.

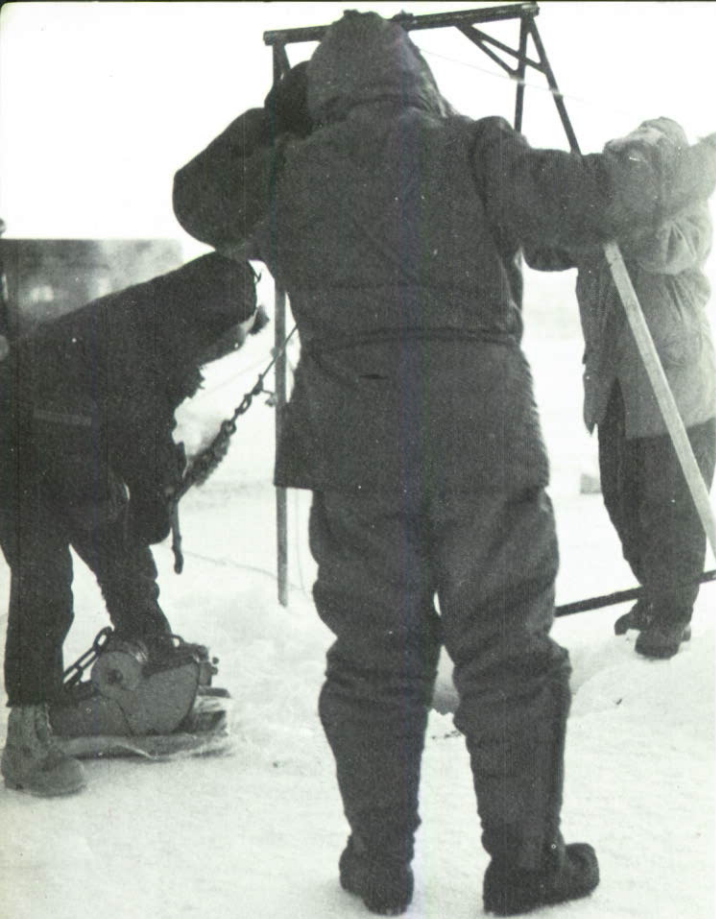
Bottom sampling is seen on the ice placed on a plastic sheet to avoid contamination (middle left). The snowmobile was used for transportation as well as for hoisting the grab.

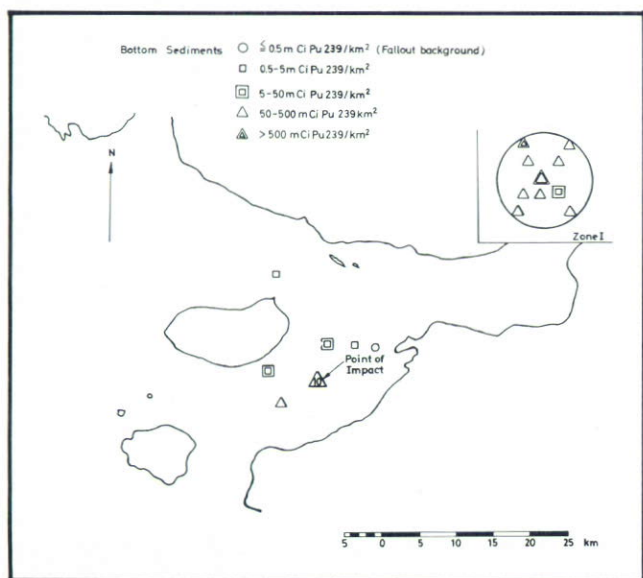
Figure 7 Pu 239 levels in bottom sediments. Ten samples were collected in zone I.

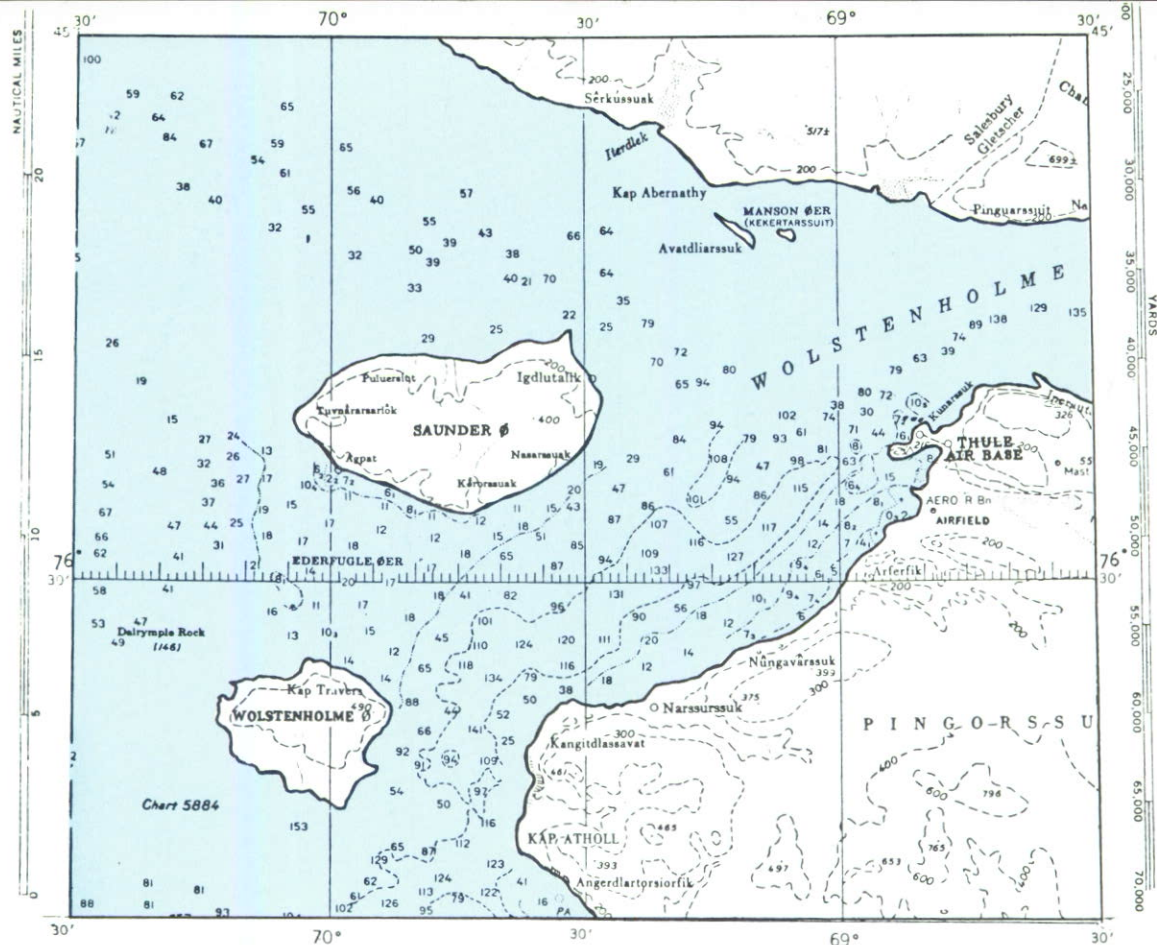
Figure 1. General Operational Locale.
